### Roxburgh Dam Flood Control Works

June/July 2003

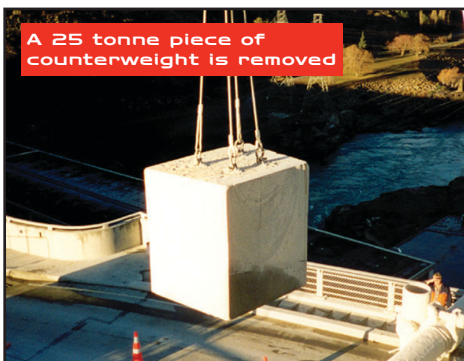
**L**owery Supa Cutters were engaged for the lowering of flood control gate piers and removal of counterweights for the installation of hydraulically operated mechanism. It was identified as a significant risk that the flood control structure atop the Roxburgh Dam could fail in the event of a seismic occurrence. The supporting piers and their counterweights required lowering and removal before a new truss and hydraulic mechanism could be installed. Of the 3 spillways, 2 must always be able to operate so work has to be staggered to allow this to happen.

Three counterweights needed to be removed, each 2.4h x 1.5w spanning the 15.5m wide spillways weighing 140 tonnes. The 4 piers were a complicated "H" section with machinery platforms and walls cast integrally on the top, 7.4 meters was to be removed to lower them to the required level.

The counterweight removal process required the installation of a support structure to the central gate weight, wiresawing the weight into 20 tonne pieces and craned down. Rated lifting plates were attached to each block using expanding mechanical anchors and the crane used a pair of balanced strops to equalise lifting loads.

The piers could now be addressed. They were modified using 2 wiresaws mounted on top and cutting below themselves into 16-20 tonne pieces. By using a series of pulleys it was possible to first cut horizontally then turn the cutting plane 90 degrees and draw the wire up vertically. This technique meant that the cut blocks could be accurately calculated to suit the lifting capacity of the crane thereby reducing the cut area to the optimum. Each predetermined layer was cut off in this fashion and the wiresaw lowered to the next level until completion.
